UNCLASSIFIED TITLE Leading Edges Development - Dyna Soar

MODEL X-20

DOCUMENT NUMBER D2-80085

## LEADING EDGE CONCEPTS AND ATTACHMENTS - PRELIMINARY

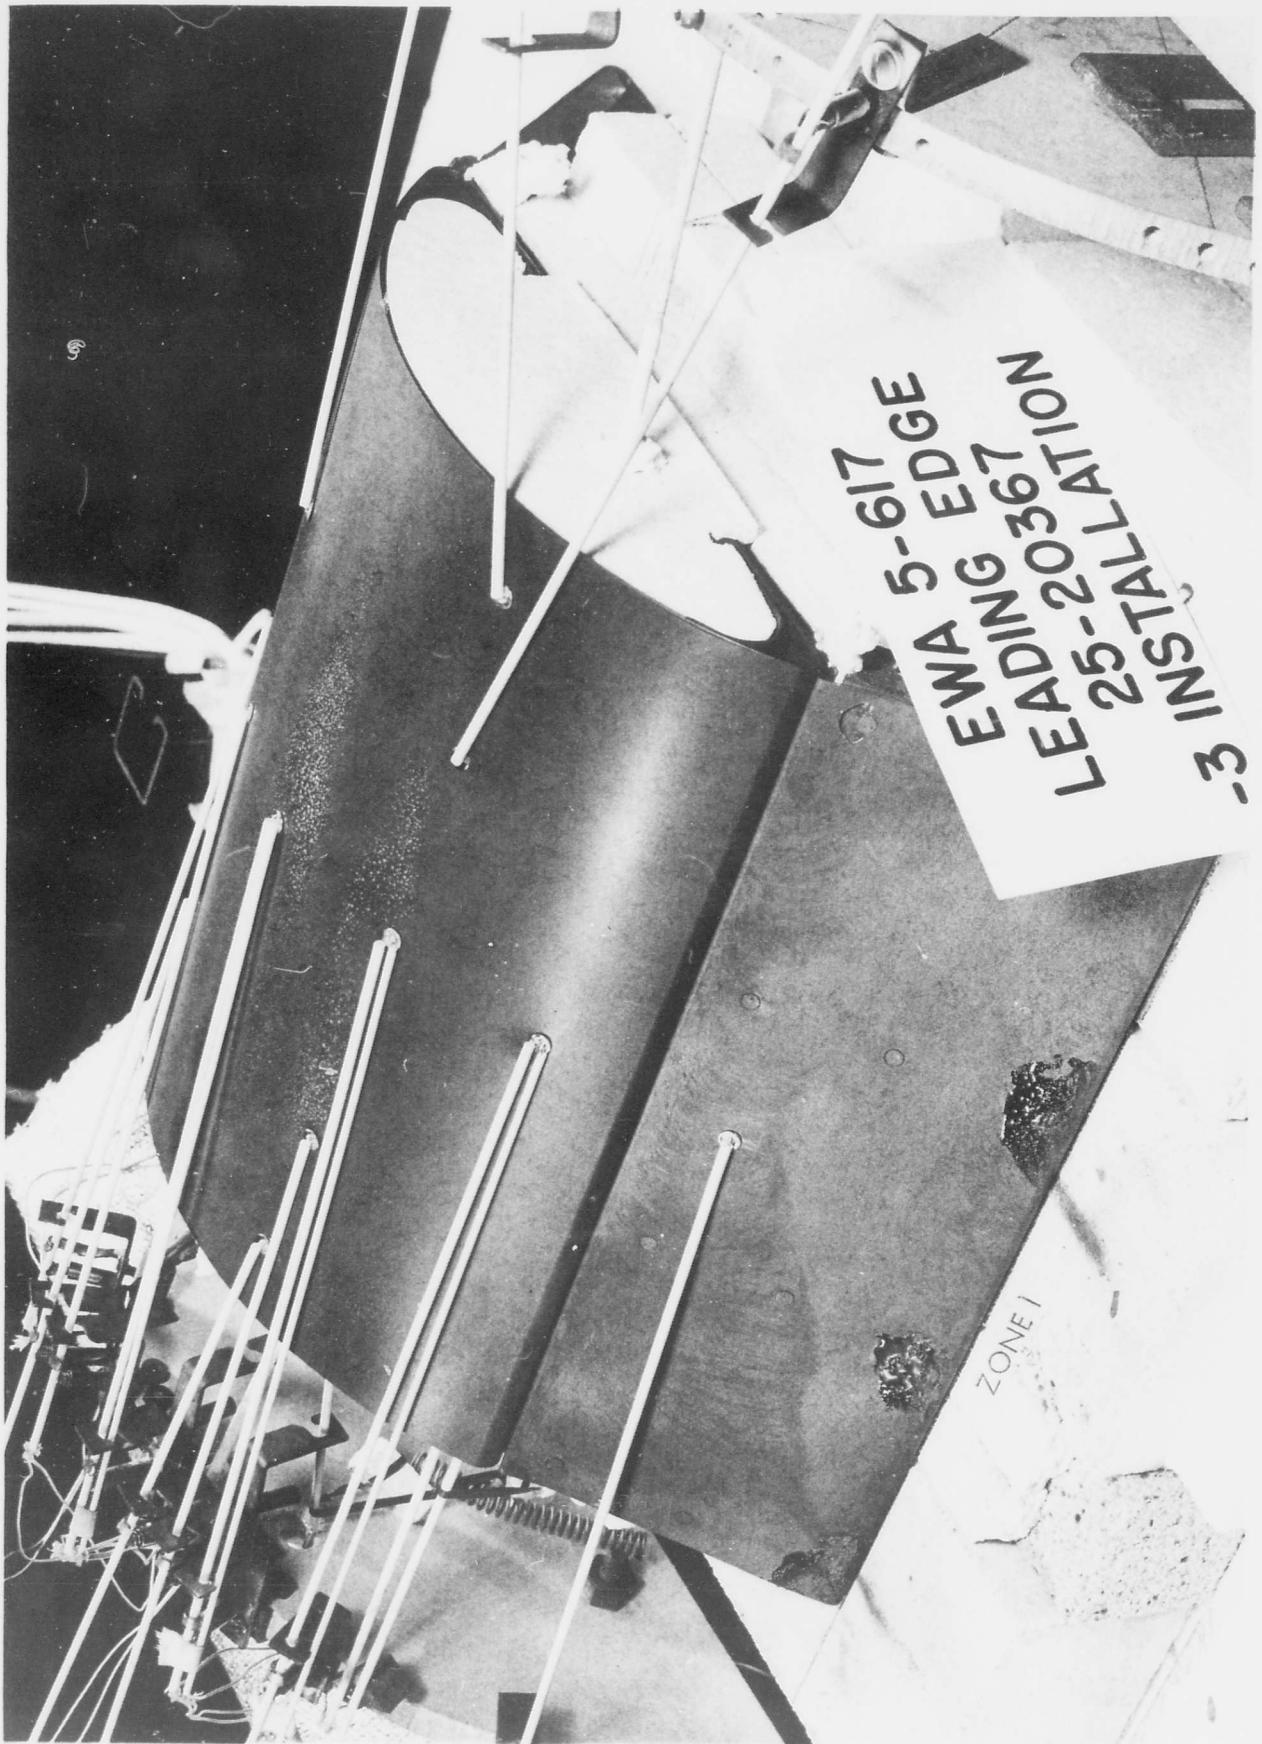
Fig. 3-66 shows pretest condition. The heat shields from a previous test were reused on this specimen. Fig. 3-67 and 3-68 show post test results. The eroded heat shields have been repaired with Sears Roebuck Furnace Cement. The coating on the leading edge segment became a little mottled, but no failures occurred.
